Report on the Paducah Gaseous Diffusion Plant Metals Recovery Program

*Department of Energy
Oak Ridge Operations
December 2000*

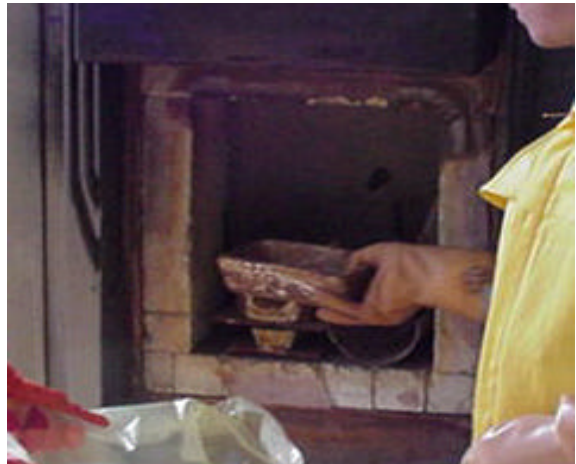
Exhibit 4 - Small furnace used to smelt reclaimed gold.

- C No radiation levels (greater than 5 mrem/hr) were found on direct readings of the gold slag, molds, crucibles, or other equipment.

A health physics technician at the site alleged that he once surveyed a crucible stored in C-746A that was stamped "C-400." The survey revealed radiation readings of several hundred mrad per hour. The technician believed that this crucible was used for melting gold. The technician toured C-746A with a representative of the team. The crucible could not be found. The team requested information on the whereabouts of this specific crucible in a bulletin that went to all Bechtel Jacobs and USEC employees at the PGDP site. No one came forth with any information about the crucible. Therefore, the allegation of high radiation readings on that particular crucible could not be substantiated.

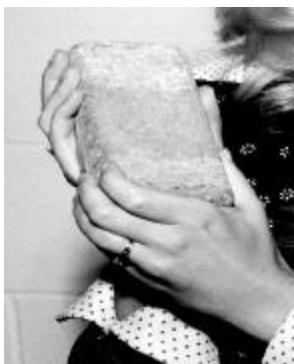
Exhibit 5 - 300 oz bar of gold.

- C No documented evidence was found that gold was surveyed or analyzed for radioactive contamination prior to sale or release from the site.

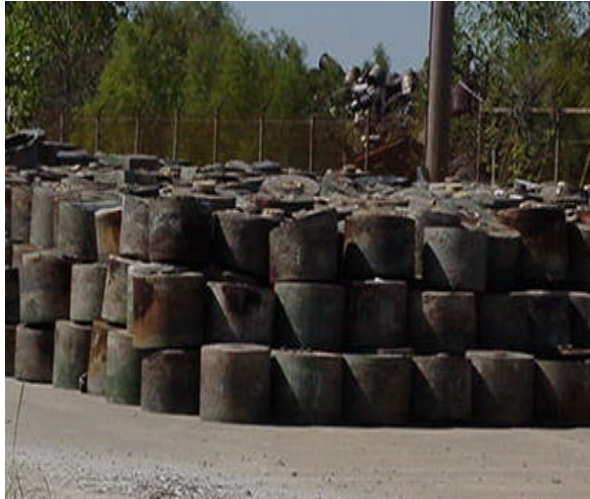
Exhibit 10 - Nickel ingots.

- C As of 1983 and possibly sooner, procedures required contamination surveys of nickel ingots that were produced in C-746A and subsequently sold. The procedure required documentation of these surveys; however, no documents were found.
